CATASTROPHES CAUSED BY CORROSION

Zoran C. Petrović

ARTICLE TYPE: Review Paper

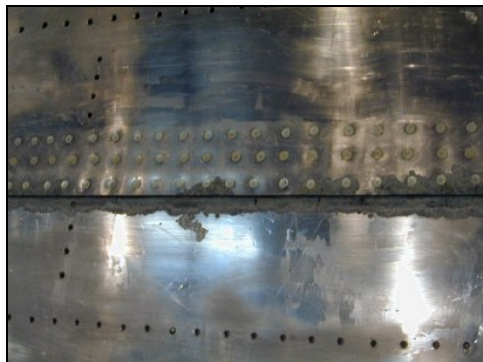
Lap joints join large panels of the fuselage skin together and run longitudinally along the fuselage. Fatigue cracking was not anticipated to be a problem, provided the overlapping panels remained strongly bonded together. A review of other similar aircraft discovered separation, corrosion and cracks in the lap joints.

Figure 2 – Fuselage skin of the Boeing 737 Aloha
Рис. 2 – Обшивка фюзеляжа самолета Boeing 737 Aloha
Slika 2 – Oplata trupa aviona Boeing 737 Aloha

Figure 2 clearly shows that the corrosion process and subsequent extensive accumulation of corrosion products within the lap joints led to the creation of so-called "pillowing", which finally led to the separation of the contact surfaces and uplifted the fuselage skin panels above the surface of the rivet heads (Komorowski, 1996).

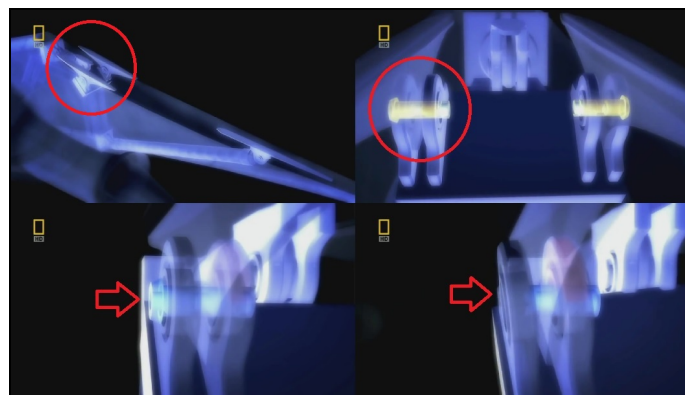
A possible reason for the shearing away of the two right engines is damage to an internal safety pin of the mid spar (Figure 4) caused by corrosion pits and fatigue.

Figure 4 – Internal safety pin of the mid spar

The inboard and outboard pylon fittings and the partial fuse pin were made of AISI 4330M low alloy steel. The inboard pylon fittings were made of high strength steel 1517 – 1655 MPa, and the safety pin was made of medium strength steel 869 – 958 MPa. This design of the fuse pin had been used from 1982 and in a seven year period there were fifteen reports of cracked pins (<http://www.corrosion-doctors.org/Aircraft/el-al.htm>).

After this accident, Boeing introduced several changes for the pylon-to-wing connections, including a newly designed safety pin made of corrosion-resistant stainless steel.

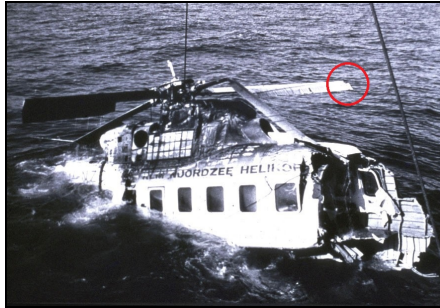
In May 1974, the helicopter Sikorsky S-61N PH-NZD crashed into the North Sea, and six people were killed. Figure 5 shows the crashed helicopter during its recovery from the water. All the main rotor blades were broken, but blade No. 3 was an exception because of low deformation at the fracture (indicated in Figure 5).

Figure 5 – Recovery of the helicopter Sikorsky S-61N PH-NZD from the North Sea
 Рус. 5 – Извлечение вертолета Sikorsky S-61N PH-NZD из Северного моря
 Slika 5 – Spasavanje helikoptera Sikorsky S-61N PH-NZD iz Severnog mora

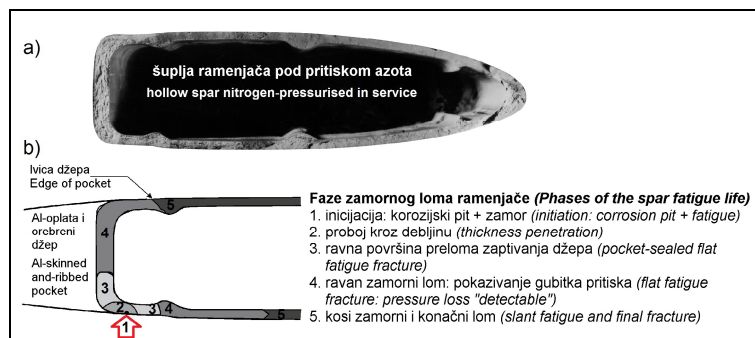
Figure 6 shows a cleaned fracture surface of the blade spar No.3, made of aluminum alloy AA6061-T6. The spar is adhesively bonded to the sheeting in the form of a ribbed aluminum pocket, as shown in Figure 6b. The fractographic analysis determined the phases of the spar fracture and their order. The first phase was high-cycle fatigue initiated by corrosion pits on the spar lower surface under the bonded area (indicated by the red arrow in Figure 6b) (Wanhill, 2009).

Figure 6 – Recovered blade spar fracture surface and the phases of the fatigue life
 Рус. 6 – Поврежденная поверхность лонжерена лопасти и фазы усталости
 Slika 6 – Oštećena površina preloma ramenjače lopatice i faze zamornog loma

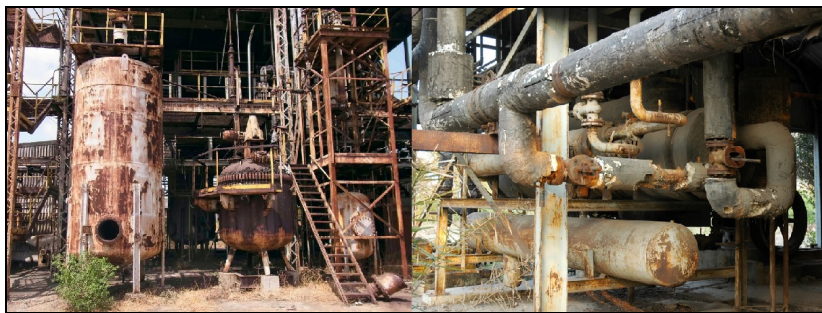
Figure 7 – Elements of the UCIL pesticide plant in Bhopal
Рис. 7 – Завод по производству пестицидов UCIL в Бхопале
Slika 7 – Elementi postrojenja za proizvodnju pesticida UCIL u Bopalu

As already mentioned, the immediate cause of the chemical reaction was the rush of 500 liters of water into the MIC storage tank. Many researchers and scientists have agreed that the corrosion of the pipelines and other safety equipment are the main culprit for this disaster. The following facts support this statement (Nitin, nd):

- MIC was stored in three double-walled stainless steel tanks, codenamed 610, 611 and 619. One of the third shift workers noticed that the pressure in tank 610 (the tank from which all MIC leaked) increased from 2 psi as it had been recorded one hour before, in the previous shift, to about 10 psi. Pressure increase for more than five times in an hour was not taken seriously because of the belief that the instrument for measuring pressure was faulty. Shakil Qureshi, the supervisor on duty, said later: "The instruments were often not working. They were corroded."

- How water entered the pipeline connected to the MIC tank made of stainless steel is a different story, but its entry inside the tank was related to improper maintenance of the valve between the pipeline and the tank. In this case, the valves were made of carbon steel which easily corrodes in acidic media, which actually happened in the factory. In addition, sliding back panels, which should have prevented the entry of water through faulty valves had not been installed.

- The final blow was the fact that the tower designed to burn MIC was not usable due to the corrosion of a pipe which had not been replaced.

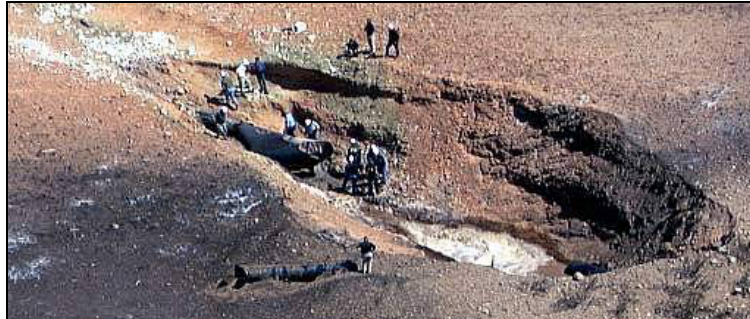
The force of the rupture and the violent ignition of the escaping gas created a crater 16 meters wide and blew out three large pieces of the pipeline. All three ejected pieces showed evidence of internal corrosion damage, but one of the pieces showed significantly more corrosion damage than the other two. Corrosion pits were visible on the inside surface of this piece, and the pipeline wall was significantly thinned at several locations. A perforation of the wall was visible at one location. No significant corrosion damage was visible on the outside surfaces of the three pieces or on the two ends of the pipeline remaining in the crater (National Transportation Safety Board, 2003).

Figure 8 – The crater that was created in the explosion
 Рус. 8 – Кратер, образованный в результате взрыва
 Slika 8 – Krater koji je nastao prilikom eksplozije

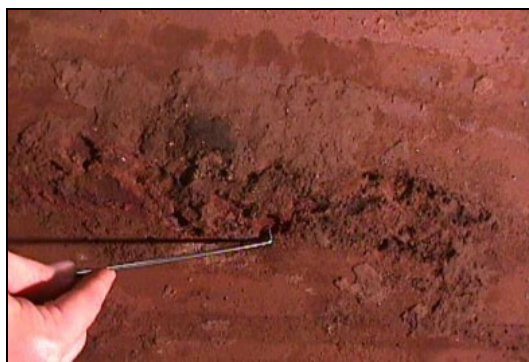
Interconnecting pits were observed on the inside of the pipe in the ruptured area (Figures 9 and 10). Striations characteristic for microbiological corrosion were observed in these pits. A pit profile showed that chloride concentration in the pits increased steadily from the top to the bottom. Increased concentrations of chloride can be caused by some kind of microbial activity. All four types of microbes (sulfate reducing microbes that produce acid, aerobic and anaerobic) which may affect the corrosion process, were found in the samples collected from the pits in one piece from line 1103 with internal corrosion, discovered after the incident 630 m away from the place of explosion. Although the individual contribution of various microbes in the corrosion process could not be estimated, the damage morphology and the corrosion product analyses data suggest that microbiological activity contributed to the corrosion process (Nitin, nd).

Figure 9 – Corrosion pitting on the inside of the pipe near the rupture site
 Рус. 9 – Питтинговая коррозия на внутренней стенке трубы в зоне разрыва
 Slika 9 – Piting korozija na unutrašnjoj strani cevi u zoni kidanja

The El Paso Natural Gas Company (EPNG) committed itself to spend \$ 86 million on the replacement of 10,000 miles of the gas pipelines destroyed in the incident. Also, after this accident, the EPNG company developed a program to train staff on internal corrosion and implemented a program for integrity management which applies to 46,000 miles of the gas pipelines of the company. The EPNG identified 60 segments of the pipelines with the estimated risk of internal corrosion. These segments were inspected by non-destructive methods and internal corrosion was discovered on 8 pipelines. In the metallurgical laboratory of the company, on one of these lines, the experts found general internal corrosion which had reduced the thickness of the pipe wall for about 42% (<https://abduh137.wordpress.com/2008/04/28/the-50-major-engineering-failures-1977-2007-part-3>).

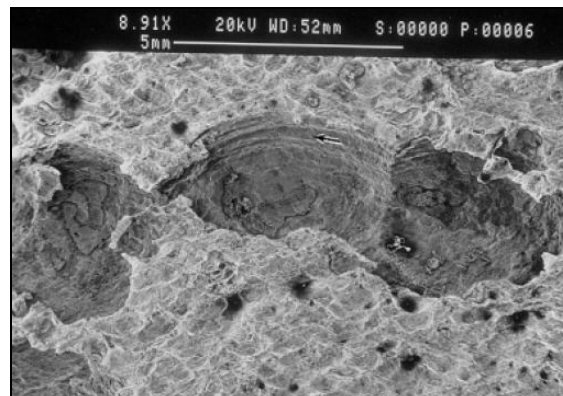
Figure 10 – Microscopic view of a corrosion pit in the Carlsbad pipeline
 Рис. 10 – Микрографическое изображение питтингов на трубопроводе в Карлсбаде
 Slika 10 – Mikrografski snimak korozivnog pita u cevovodu Carlsbad

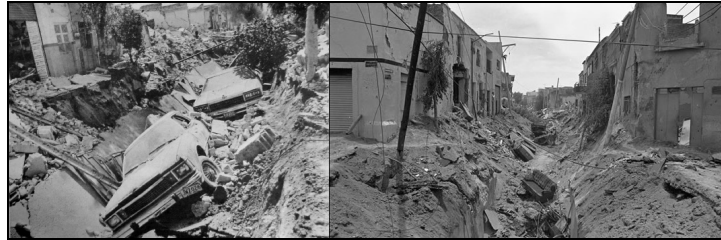
The explosions took place in Guadalajara on 22 April 1992, in the downtown district Analko. In a number of explosions of gas in the sewage system, 8 kilometers of streets were destroyed. Officially, by the Lloyd's of London accounting, 252 people were killed, nearly 1,500 were injured and 15,000 people were left homeless.

Figure 11 – Aftermath of the Guadalajara sewer explosions
Рус. 11 – Последствия взрыва канализации в Гвадалахаре
Slika 11 – Posledice eksplozije kanalizacije u Gvadalahari

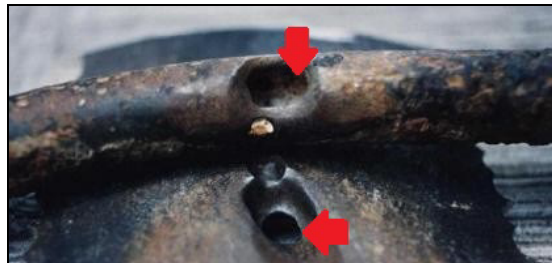
The sewer explosion was traced to the installation of the water pipe which had been placed above the gas installations several years before the explosion. The corrosion of the water pipes caused water leaks out of them, which subsequently caused the corrosion of the gas pipes and gas leaks in the sewers (Nitin, nd).

Figure 12 – Corrosion pits in the water pipelines
Рус. 12 – Коррозионные питтинги на трубе водопровода
Slika 12 – Korozivni pitovi u vodovodnim cevima
