# STUDY OF THE STRESS-STRAIN STATE OF BUSBAR PUNCHING TOOLS RESTORED BY VARIOUS METHODS

The aim of this study is a comparative analysis of the stress–strain state of busbar punching tools after restoration using different methods. An overview of existing methods for restoring punches and dies was conducted. The analysis showed that each method has its own advantages and limitations. To address this issue, two restoration methods for the busbar punching tool are proposed: hardfacing of worn and damaged surfaces, and replacement of the working part with an insert made of carbon steel. A numerical simulation using the ANSYS software package was carried out to investigate the stress–strain state of busbar punching tools restored by two proposed methods. The simulation focused on determining the stresses in the working zones of the tool, deformations, and the distribution of contact forces. The results made it possible to identify critically loaded areas of the tool design and evaluate the effectiveness of the proposed restoration and modernization methods. The research, the results of which are presented in this article, is funded by the Committee on Science of the Ministry of Science

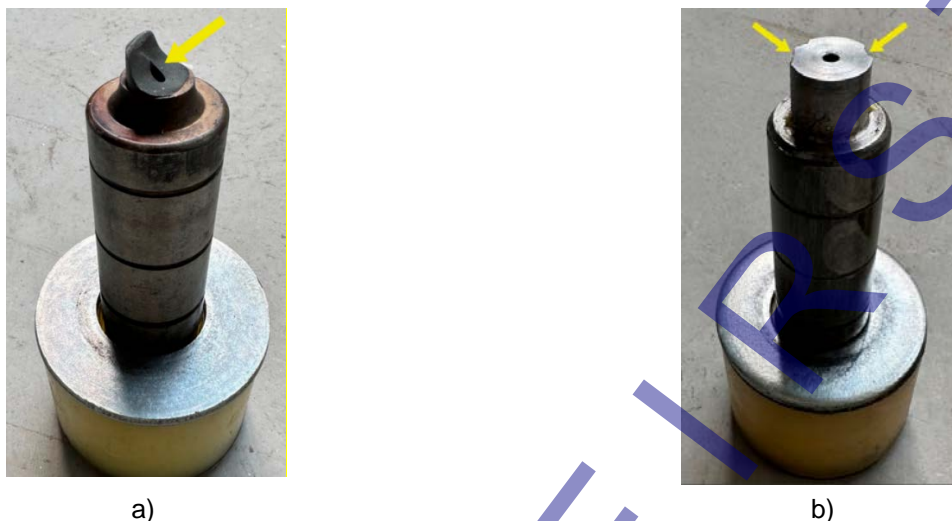
Figure 1 shows worn-out busbar punching tools.

Fig. 1. Worn busbar punching tools

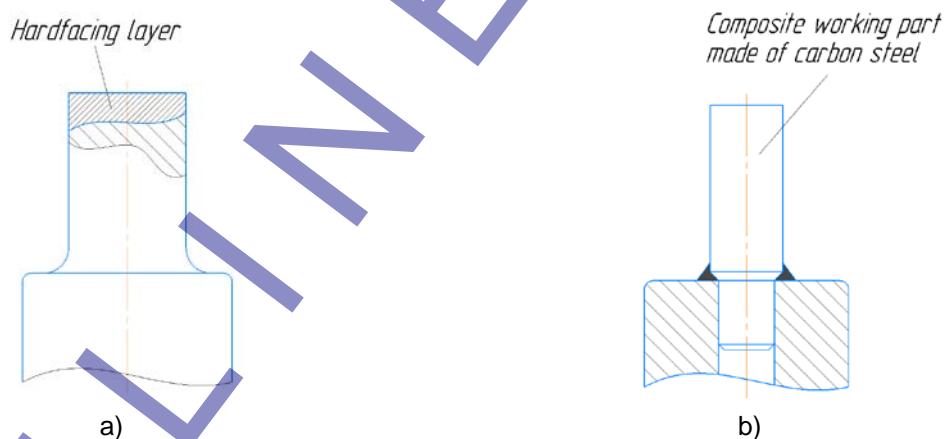
Figure 2 shows the proposed methods for restoring busbar punching tools.

Fig. 2. Methods for restoring busbar punching tools: a – restoration by hardfacing; b – composite tool design

One of the research directions involves the restoration of worn working surfaces of the tool by means of hardfacing (Figure 2a). As the hardfacing material, ESAB OK Tubrodur 35GM wire was used, known for its high wear resistance and hardness. During the experimental work, optimal hardfacing parameters were determined to ensure the required hardness and strength of the restored layer. The selection of process parameters was carried out with consideration of the operational requirements for the tool, including resistance to contact wear and impact loads.

In addition, an alternative restoration method is being developed at the department, based on replacing the worn section of the busbar punching tool's working surface with an insert made of carbon steel. Analysis showed that the majority of failures occur in the transition zone between the working part and the guide. Accordingly, a design was proposed in which the working part is manufactured separately and joined to the guide section by welding. This approach allows for reduced restoration costs while maintaining the necessary strength and performance characteristics. The structural solution of this method is shown in Figure 2b.

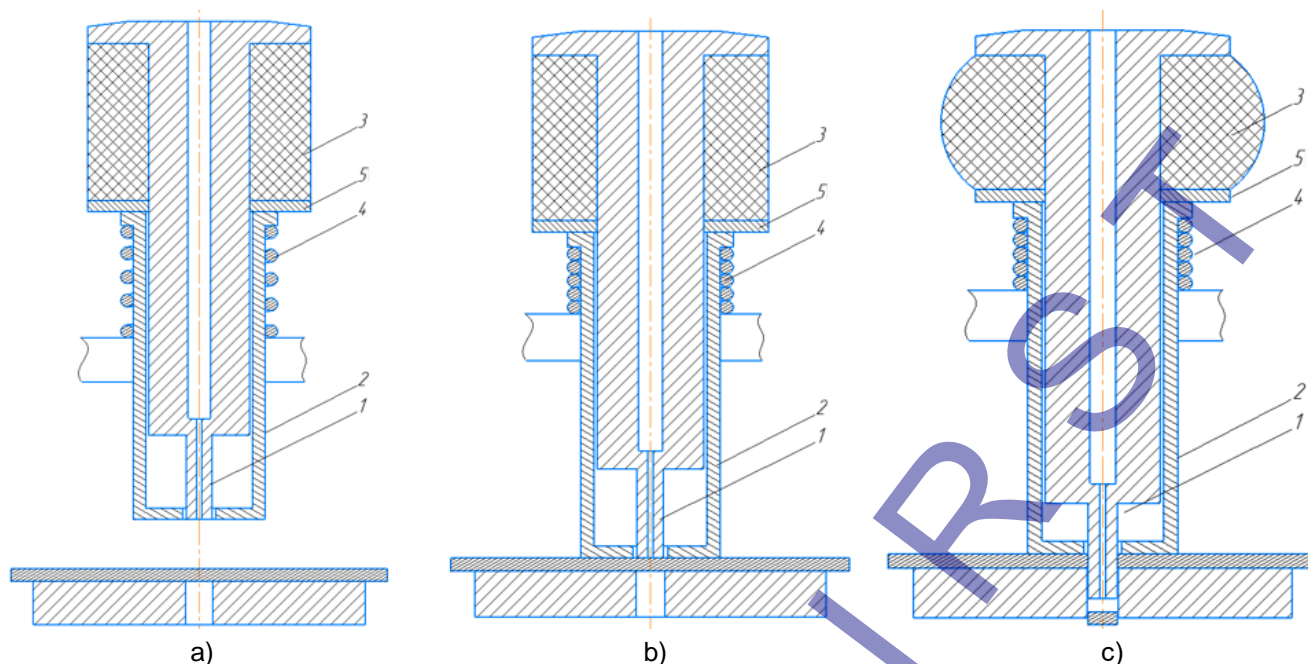
Figure 3 shows the hole punching process using a busbar punching tool.

Fig. 3. Hole punching process using a busbar punching tool: a – tool setup; b – beginning of the hole punching process; c – hole punching process; 1 – punch; 2 – punch holder; 3 – buffer; 4 – spring; 5 – washer

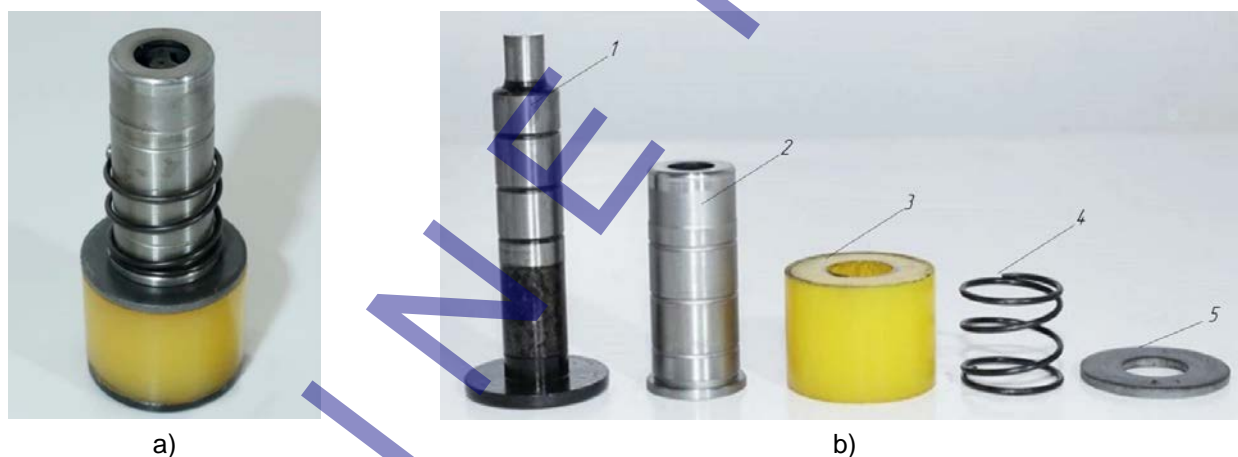
Figure 4 shows the exploded view of the busbar punching tool.

Fig. 4. Design of the busbar punching tool: a – assembled tool; b – exploded view: 1 – punch; 2 – punch holder; 3 – buffer; 4 – spring; 5 – washer

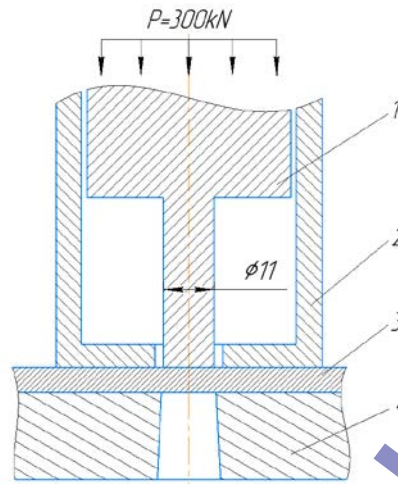
Figure 5 shows the simulation model of the die in interaction with the punch and the press workpiece.

Fig. 5. Simulation model of the die interacting with the punch and the press workpiece: 1 – punch; 2 – punch holder; 3 – plate (workpiece); 4 – die

In the ANSYS environment, contact interactions were taken into account at the punch–workpiece and workpiece–die interfaces. The punching force was set as  $P = 300$  kN.

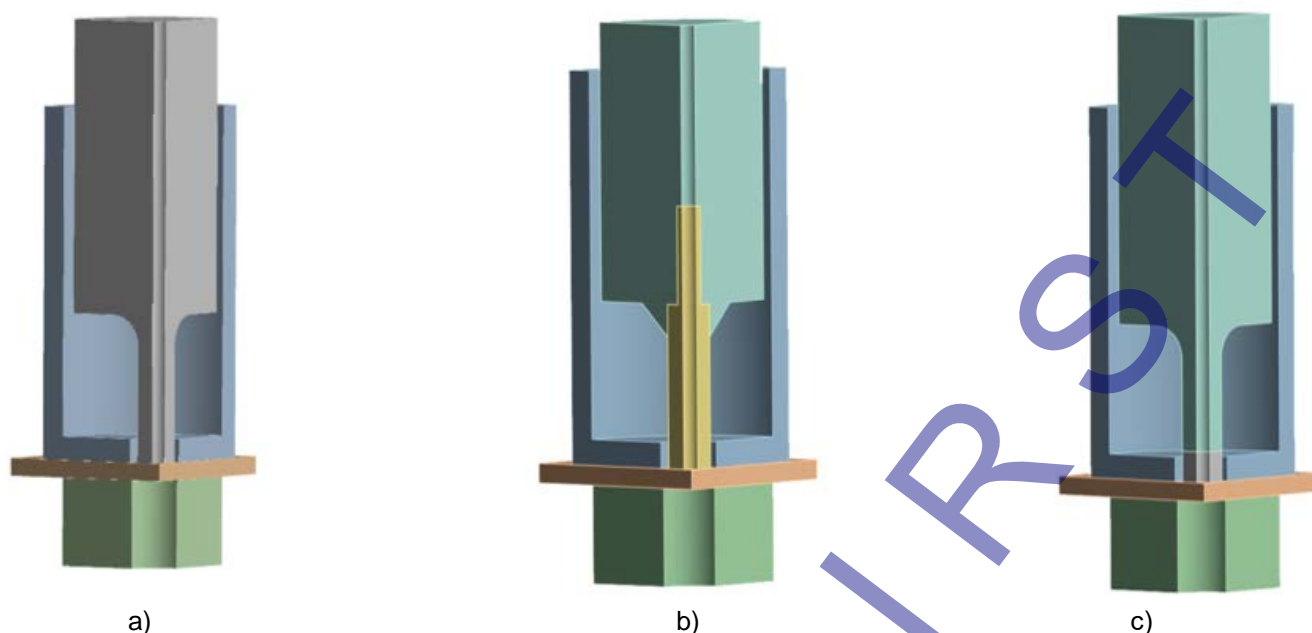
A finite element model of the investigated object was developed in the simulation environment (Figure 6).

Fig. 6. Finite element model: a – initial model; b – assembled (composite) model; c – model restored by hardfacing (welding deposition) method

To improve computational efficiency and reduce calculation time, a quarter-symmetry model of the full geometry was used. This approach is a standard practice in finite element analysis (FEA) when both geometry and loading conditions exhibit symmetry. The use of a quarter model significantly reduces the number of finite elements, which in turn decreases computation time and lowers the demand on computational resources—without compromising the accuracy of results for symmetric problems. The obtained results from the quarter model can be extrapolated to represent the behavior of the full model.

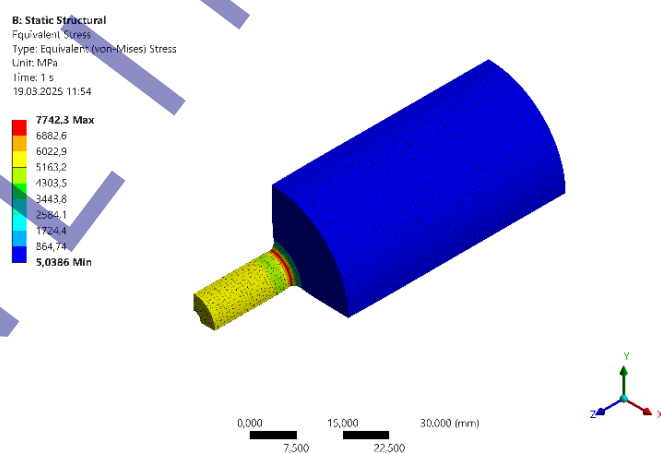
Figure 7 shows the stress-strain state of the tool made of H12M steel.

Fig. 7. Stress-strain state of the tool made of H12M steel

The color distribution on the model visually represents the stress levels in various zones of the tool. The finite element simulation enabled the precise identification of the most critically loaded areas. The analysis revealed that the highest stress concentrations occur at the cutting edge of the punch and in the transition area from the working part to the guiding section, which is typical for cutting and punching tools operating under impact and contact loads.

The peak stress reached 7742.3 MPa, which significantly exceeds the tensile strength limit of H12M tool steel, typically ranging from 2500 to 3000 MPa after optimal heat treatment. Such a high value indicates a very high risk of failure: either plastic deformation or, more likely, brittle fracture may occur during the first punching cycle or after only a few cycles. This confirms the need for structural improvements and the implementation of restorative technologies.

It was revealed that the most highly stressed area of the punch is its cutting edge and the transition zone from the working section to the guide section with a larger diameter. The peak stress value reached 7742.3 MPa, which is unacceptable for H12M tool steel. This condition highlights the need for further experimental and analytical studies, as well as, if necessary, the application of additional hardening methods.

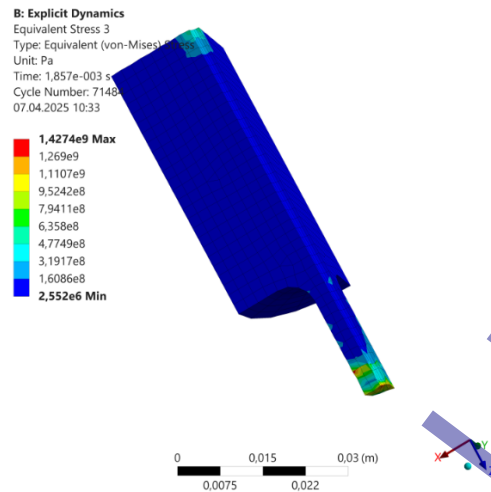
Figure 8 shows the stress-strain state of the tool restored by hardfacing.

Fig. 8. Stress-strain state of the tool restored by hardfacing

The finite element simulation results, performed using explicit dynamic analysis, show the distribution of von Mises equivalent stresses in the working tool restored by hardfacing with Tubrodur wear-resistant flux-cored wire. The image reveals peak stress values up to 1427.4 MPa, concentrated along the cutting edge of the tool, indicating extremely high loading in this area during the punching process (see Figure 8).

The simulation confirms that both the tool body and the deposited hardfacing layer can withstand the calculated operational loads without immediate failure according to the von Mises failure criterion.

Simulation of the tool restored using hardfacing with wear-resistant ESAB OK Tubrodur 35GM powder wire revealed that the stress concentration at the cutting edge reaches 1427.4 MPa. Under these conditions, the tool and deposited layer are able to withstand the operational loads without immediate failure according to the von Mises criterion.

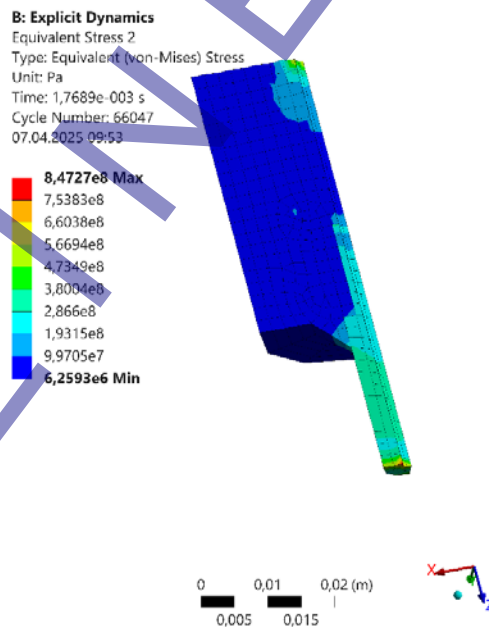
Figure 9 presents the stress-strain state of the composite (modular) tool.

Fig. 9. Stress-strain state of the composite tool

The highest stress levels, indicated in red on the color scale, are concentrated exclusively along the cutting edge of the tool. As the distance from the cutting edge increases into the body of the tool, the stress values rapidly decrease, transitioning from maximum to significantly lower levels.

For the working part of the tool made from carbon steel, a value of 847.27 MPa is within the acceptable range. Carbon tool steels (such as U8, U10, U12) after proper heat treatment (quenching and tempering) can exhibit yield strengths ranging from 600 to 1000 MPa, and ultimate tensile strengths from 1000 to 1200 MPa or more.

Thus, the obtained maximum stress is likely within the allowable strength limits of high-strength tool-grade carbon steel. This indicates that, under the given load level, the cutting edge of the tool is not expected to fail immediately and is capable of withstanding such stresses without undergoing significant plastic deformation or brittle fracture.

In the case of the tool restored by replacing the working part with a carbon steel insert, simulation showed that the maximum stress in the working zone reached 847.27 MPa, which is within the allowable strength limits for high-strength tool-grade carbon steel.
