CATASTROPHES CAUSED BY CORROSION

Zoran C. Petrović

ARTICLE TYPE: Review Paper

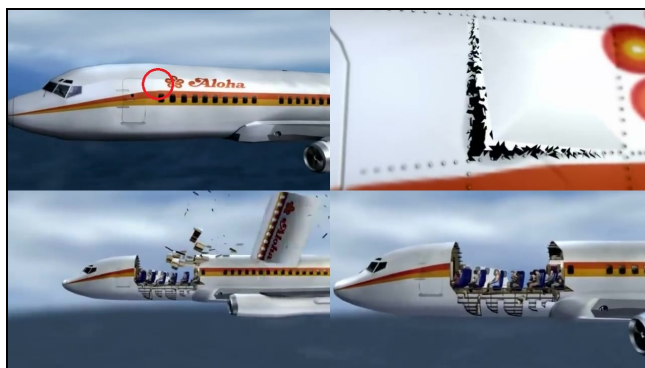
Structural damage to the plating on the Boeing 737 aircraft, operated by the US airline Aloha Airlines, which took place on 28 April 1988, undoubtedly contributed to the creation of awareness of aircraft aging. This aircraft suffered very serious damage caused by explosive decompression during flight. At 8,000 m above the ground, a large segment of the upper fuselage was literally torn off and it made a big hole in the passenger cabin (Miller, 1990).

Figure 1 – Simulation of the flight of an airplane Boeing 737 Aloha Airlines, Flight 243
 Рус. 1 – Моделирование полета самолета Boeing 737 Aloha Airlines Flight 243
 Slika 1 – Simulacija leta aviona Boeing 737 Aloha Airlines Flight 243

The crew landed the plane safely on the island of Maui in Hawaii. One flight attendant got killed, while 65 out of 94 survivors were injured. In the remaining structure of the aircraft, in several lap joints of the fuselage skin, in the holes of the upper row of fasteners, subsequent investigations discovered more cracks caused by fatigue (Wildey, 1990).

In the skin of the Aloha Boeing 737 aircraft, multiple damage was found in the form of cracks caused by fatigue which had led to the final structural damage. The report of the National Committee for Traffic Safety, made after the completion of the investigation in 1989, attributed the responsibility for the incident to the program of maintenance and detection of damage from corrosion. Earlier, in 1981, a similar plane suffered an in-flight break-up with more than one hundred fatalities. Investigations have indicated the existence of damage mechanisms to the fuselage skin panels caused by fatigue assisted by corrosion (<http://www.corrosion-doctors.org/Aircraft/Aloha.htm>).

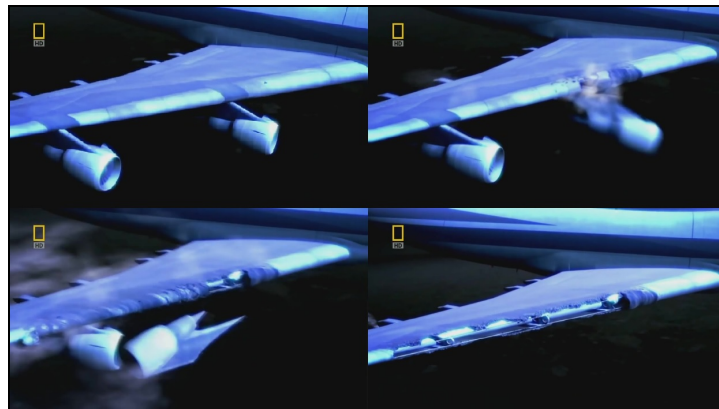
About five minutes after the take off, engine No 3 and its pylon separated from the right wing in an outboard and rearward direction. Engine No 3 hit engine No 4, causing this engine and its pylon also to separate from the wing. Both engines and pylons fell into a lake about 25 km of Schiphol. During the engine separations, the wing leading edge was extensively damaged. This damage and loss of the two engines made control of the aircraft extremely difficult. An attempt was made to return to Schiphol, but tragically to no avail.

Figure 3 – Simulation of the El Al Flight 1862 crash in Amsterdam
Рис. 3 – Моделирование аварии самолета El Al Flight 1862 в Амстердаме
Slika 3 – Simulacija udesa aviona na letu 1862 avio-kompanije El Al u Amsterdamu

A possible reason for the shearing away of the two right engines is damage to an internal safety pin of the mid spar (Figure 4) caused by corrosion pits and fatigue.
